JOB NO: 23 202

## Structural Assessment of Existing Fuel Jetty (Based on Inspection dated 31/08/2023)

346B Opito Bay Road, Kerikeri

For Kerikeri Cruising Club

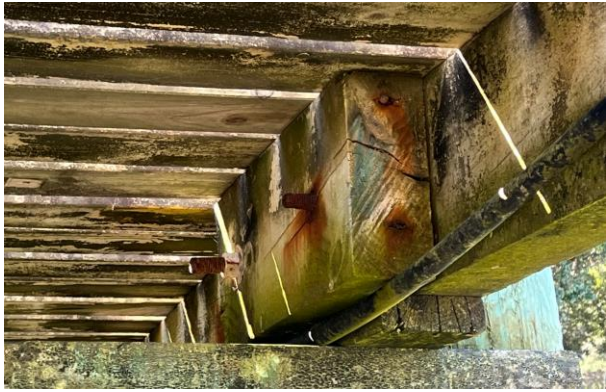
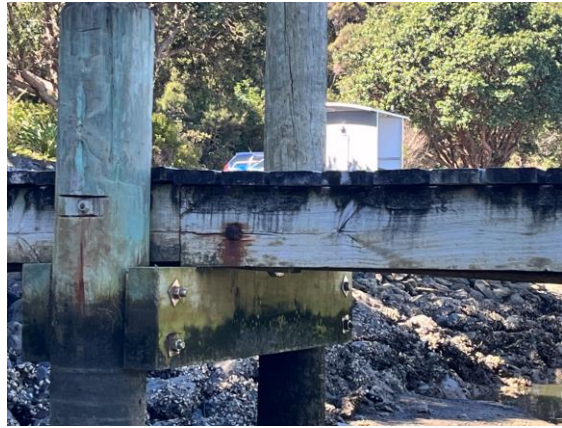
#### 2.1. Bolts, nuts & Joist hangers

Structural bolts, washers and joist hangers connecting timber pile, bearer and joists are undergoing corrosion at present they are displaying a reddish-brown or orange discoloration on their exposed surfaces. The corrosion weakens the bolt, leading to reduced load-bearing capacity and compromise the structural integrity.

With design of a new timber jetty, we recommend consideration of the increased durability by using HDPE sleeves over piles to protect from marine borer / worm damage, and SS 316 Stainless steel fixing to protect from corrosion.

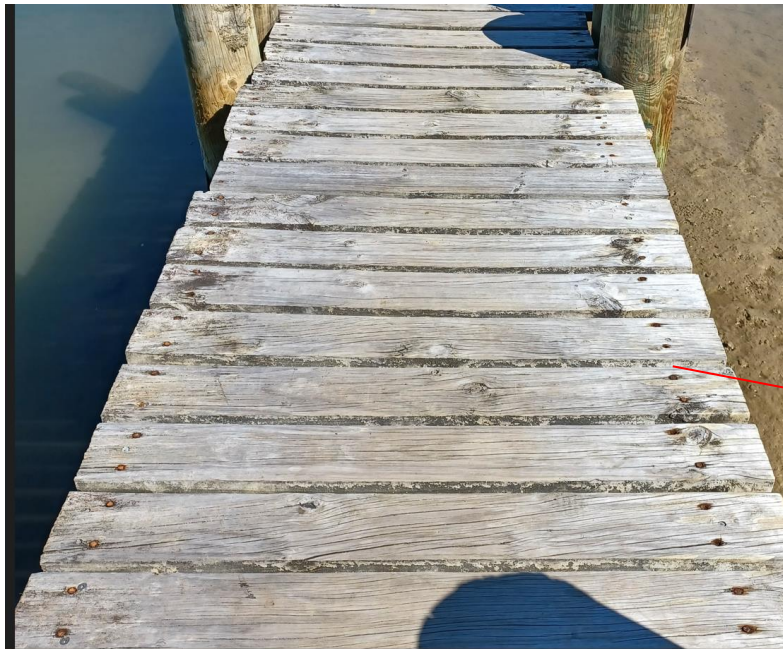
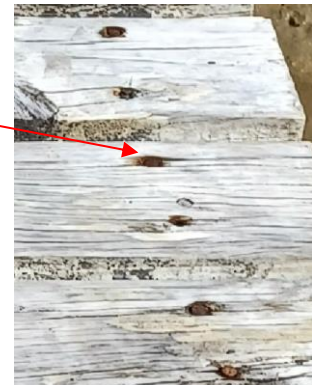
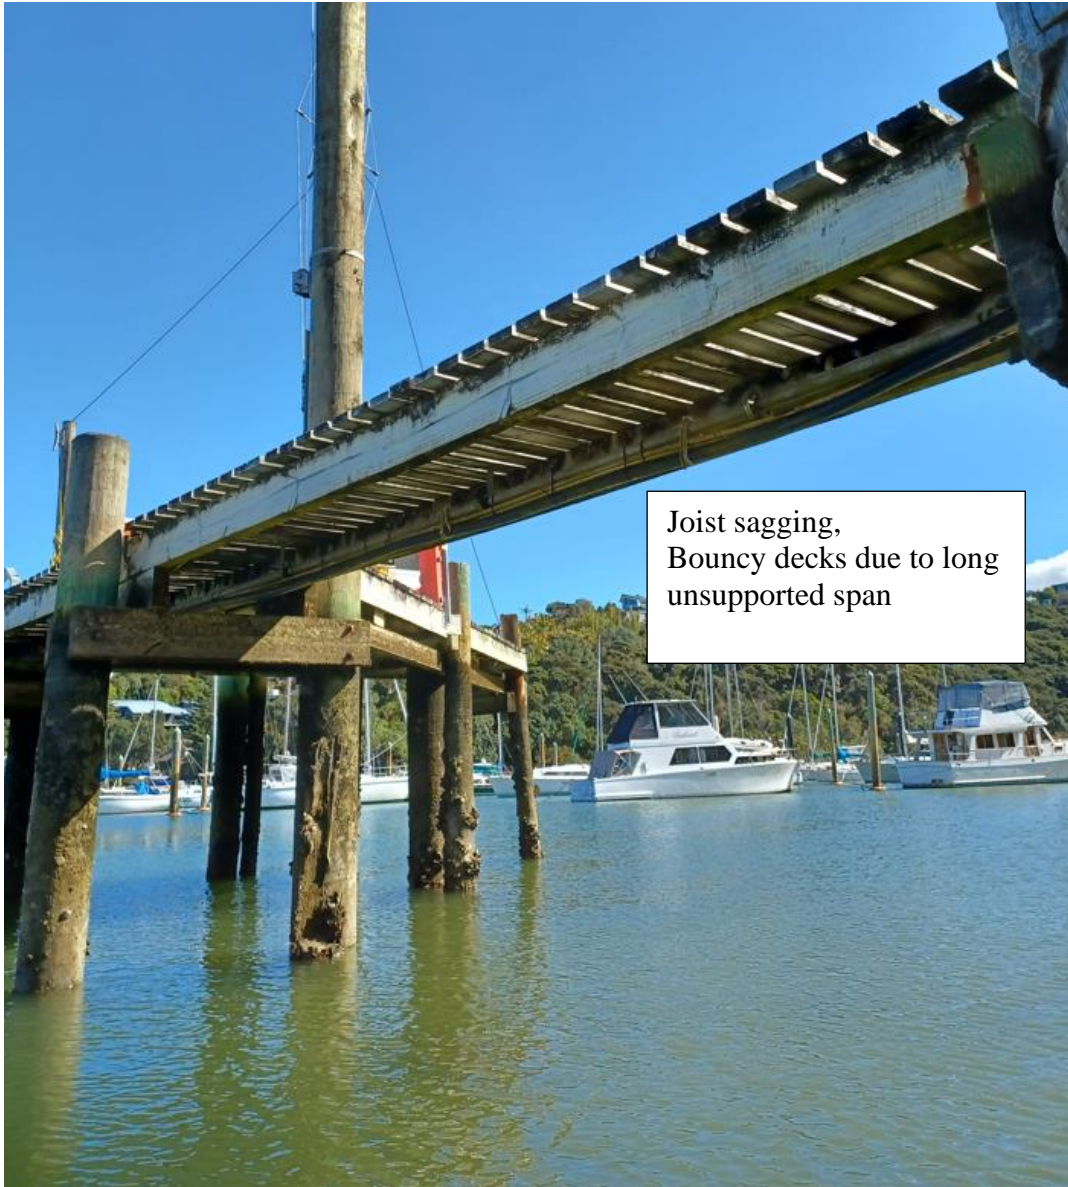
## 2.2. Timber Decking , Bearer and Joists

The deck nails are corroded. Deck planks are sagging at few locations.

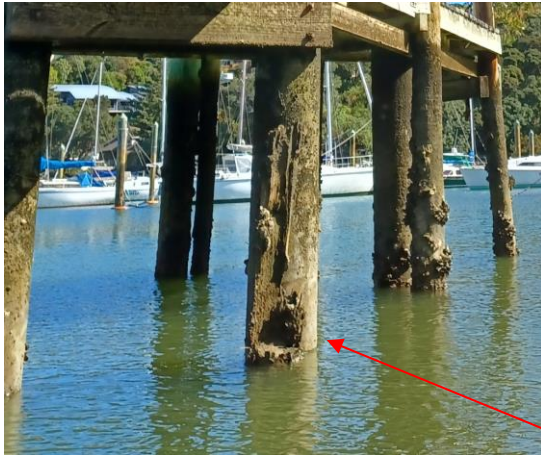
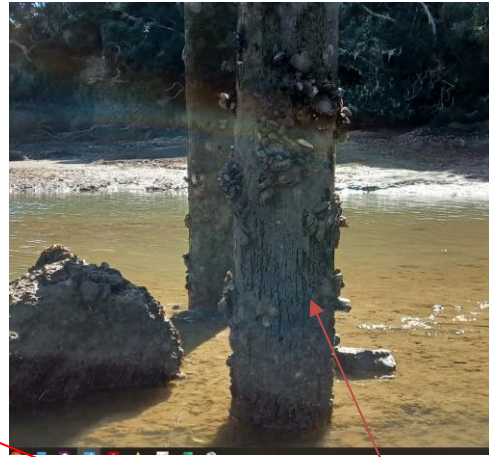
One pile beneath the jetty platform is experiencing decay. The surface of the pile has deteriorated, with the outer layer peeling off, and as a result, the section of the pile has been reduced. The reduction in the section area of the pile can severely impact the integrity of structure.

Pile displaying severe worm / Bore damage

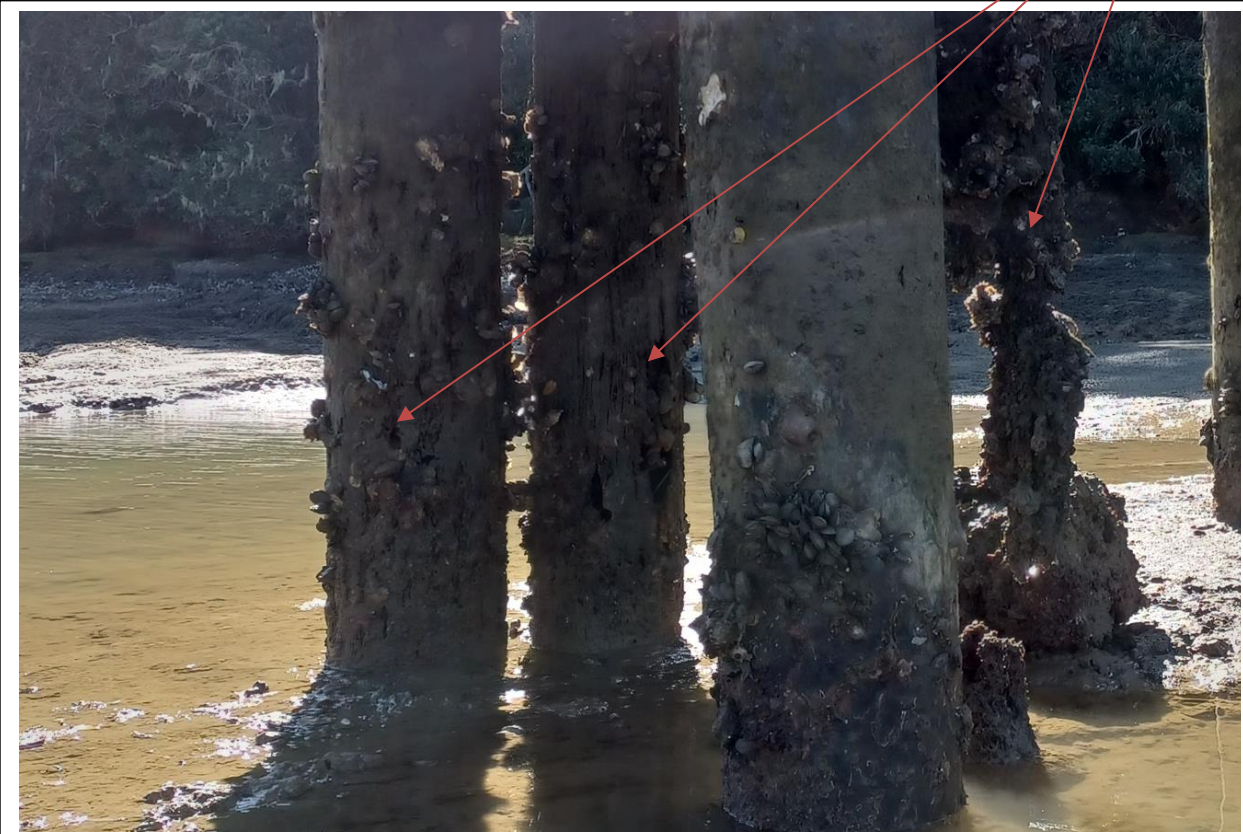
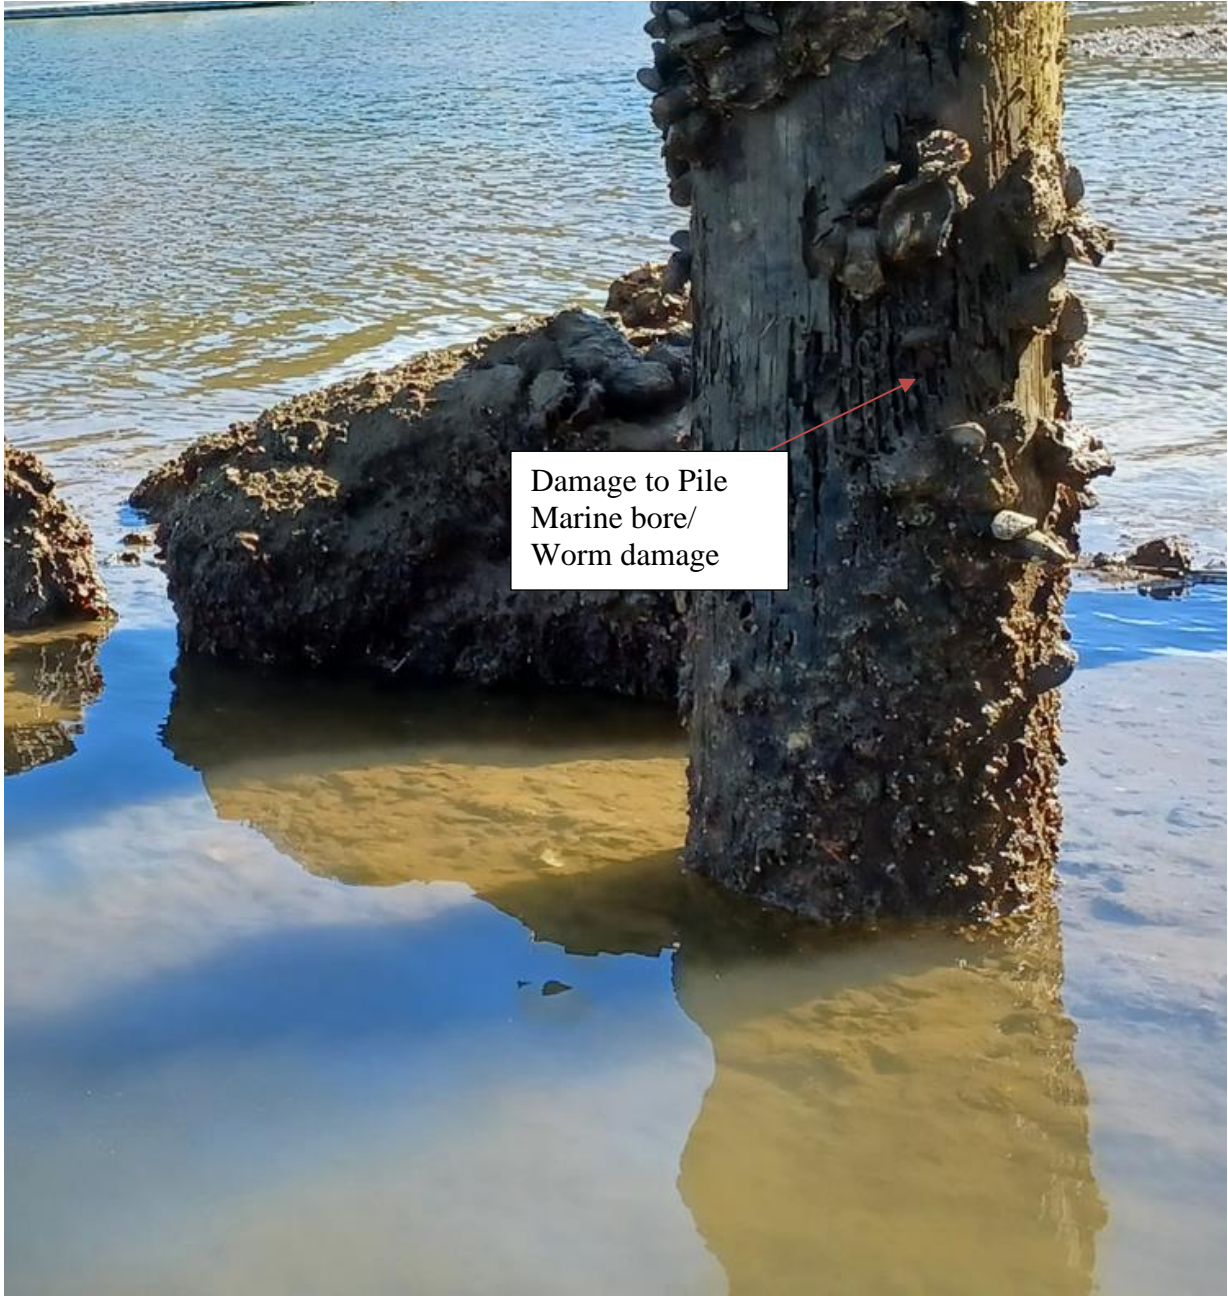
Damage to Pile  
Marine bore/  
Worm damage

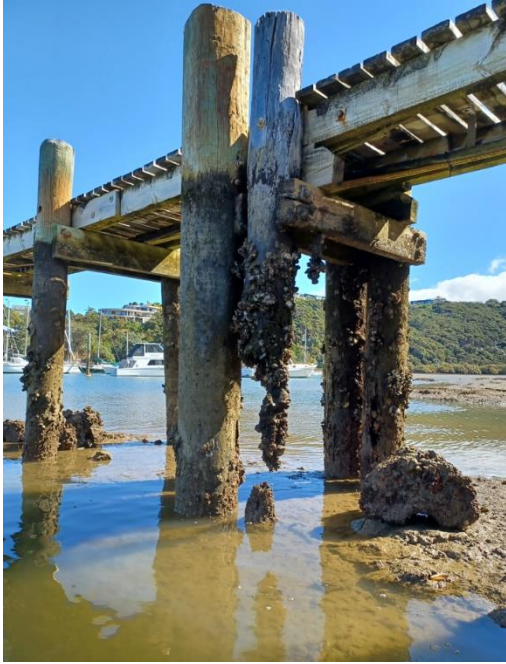
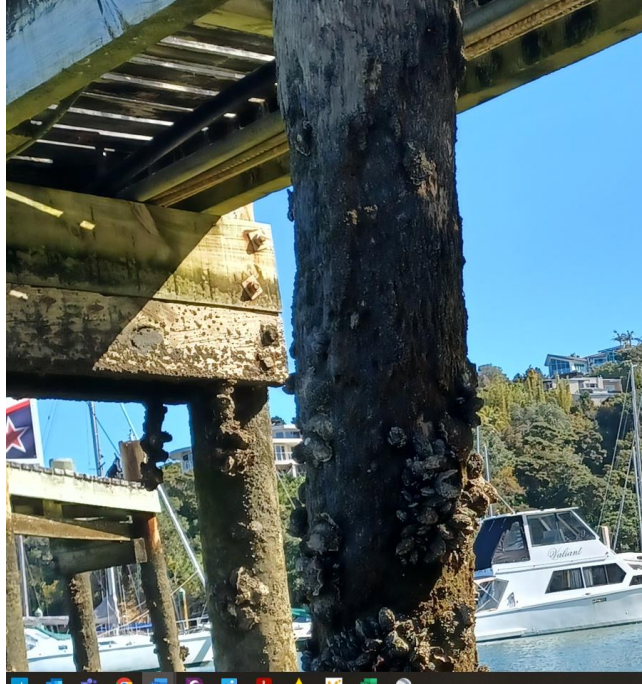
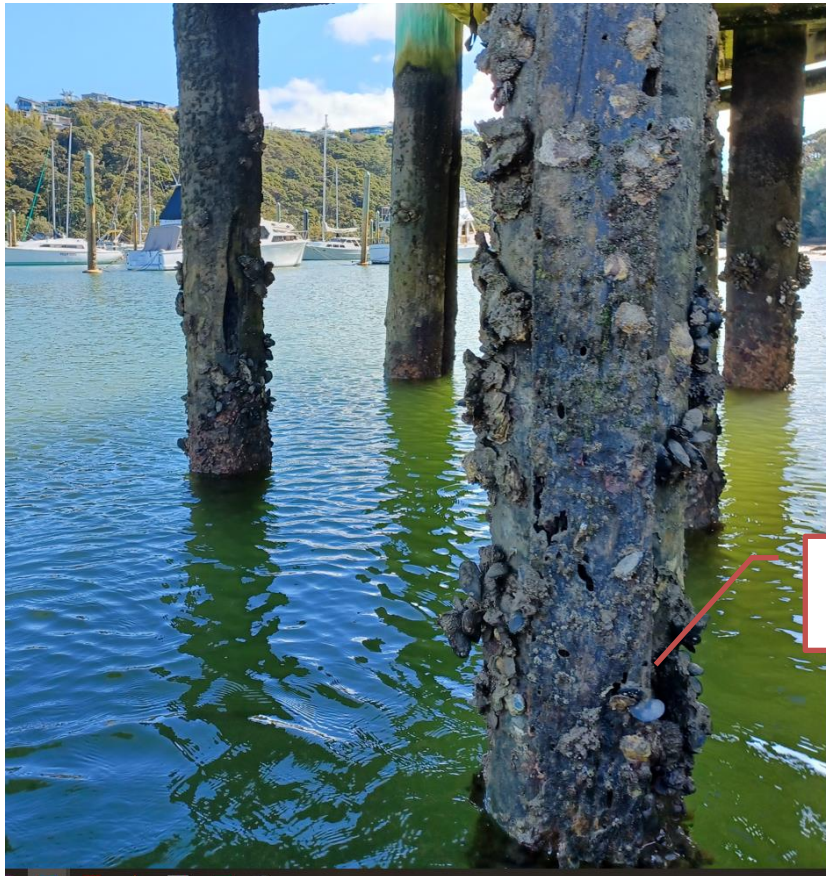
Severe Pile  
worm/bore damage

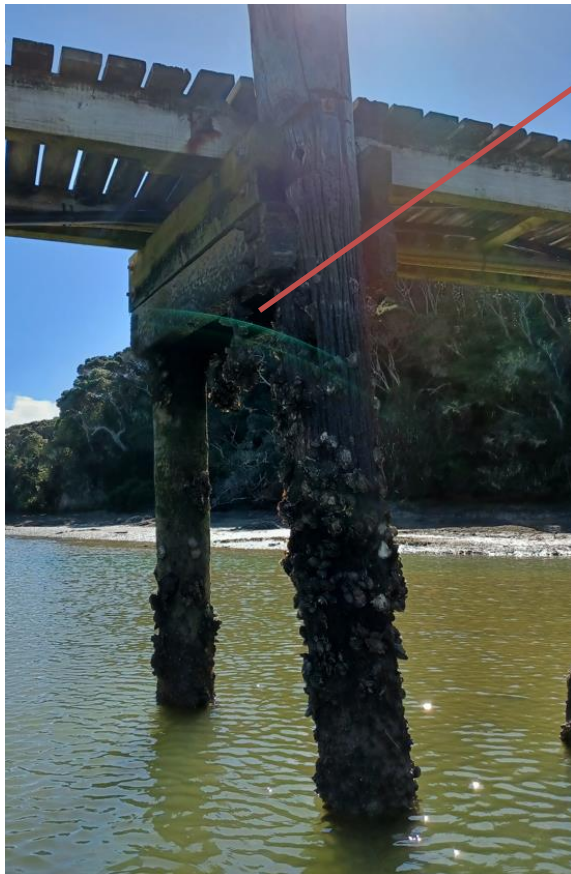
Timber splitting  
and bore / worm  
damage

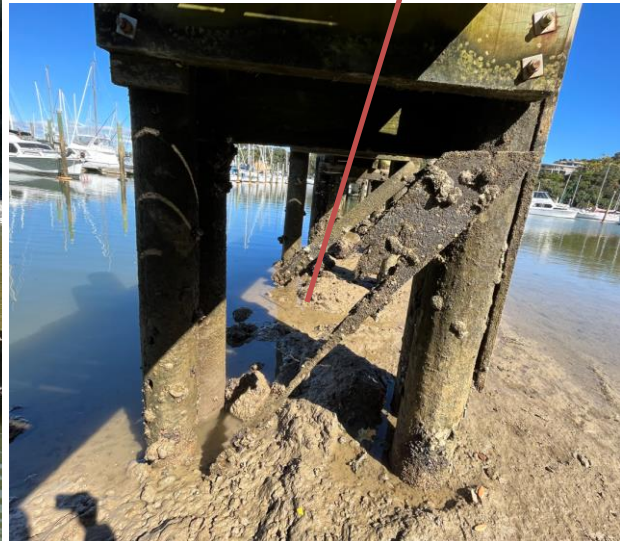
Brace  
damaged
